**Walmart Inc. (f/k/a Wal-Mart Stores, Inc.) v. Tesla Energy
Operations, Inc. (f/k/a SoalrCity Corporation)**
Document 1

**SUPREME COURT OF THE STATE OF NEW YORK
COUNTY OF NEW YORK: COMMERCIAL DIVISION**

SUMMONS

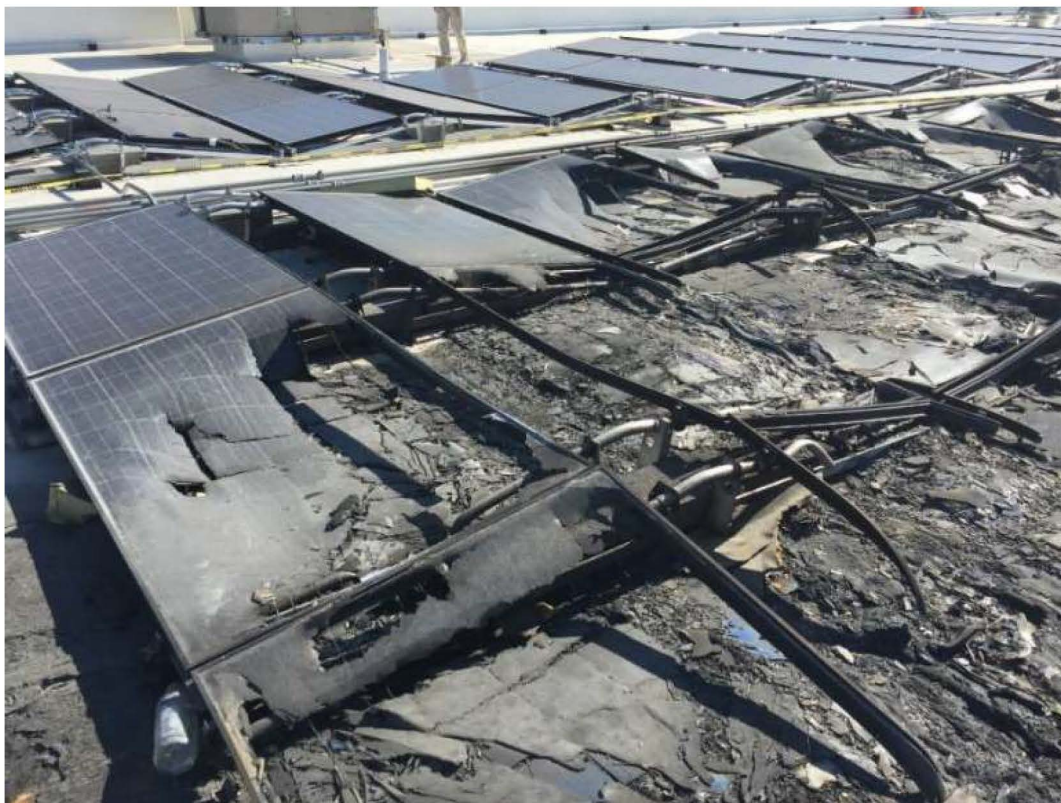
Images of Indio Fire Damage

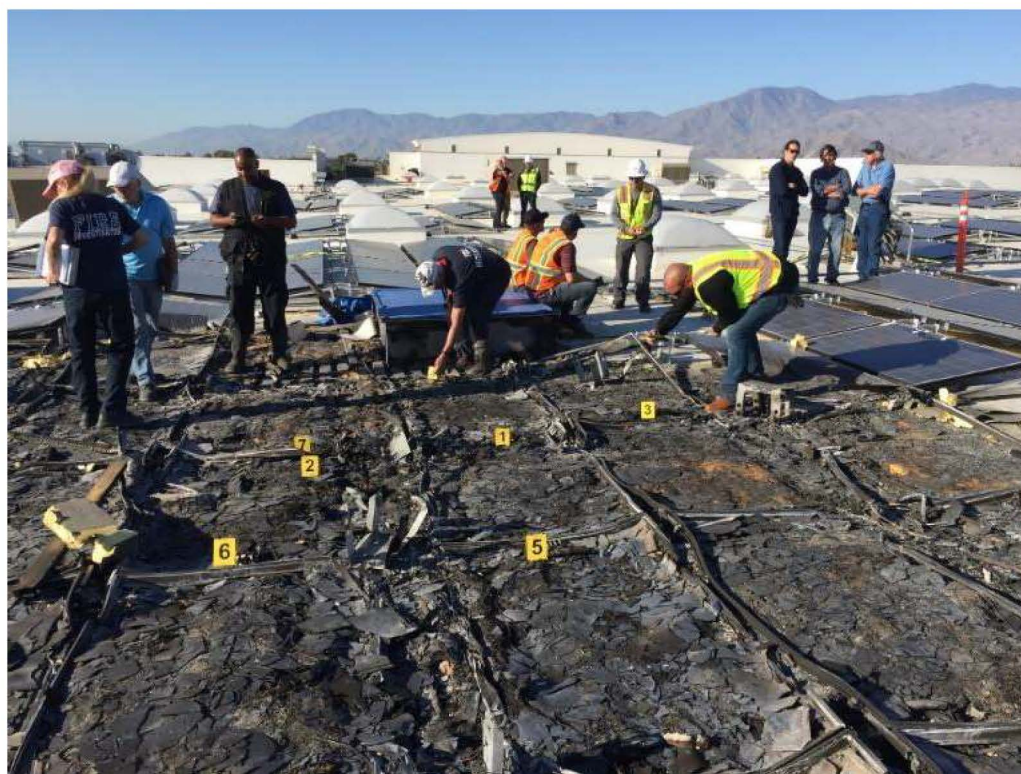
Inspection Team at Site of Indio Fire

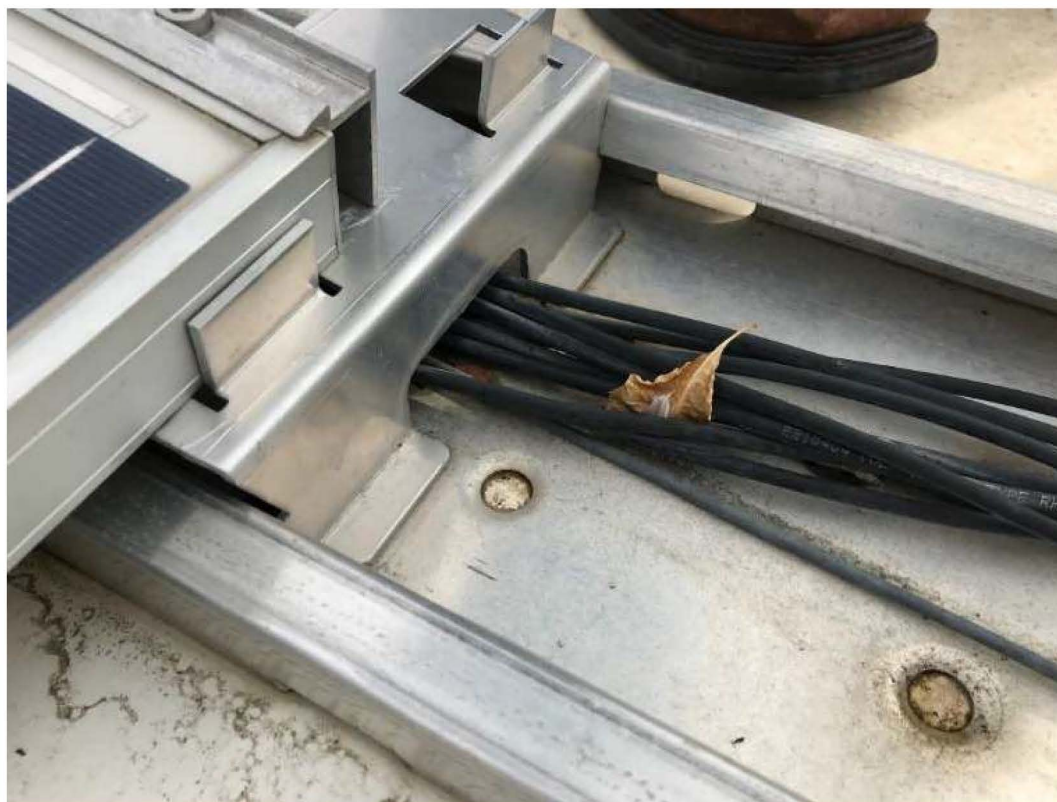
92. Poor wire management practices were also evident at multiple Walmart sites. In some cases, sharp points—from, among other items, rough concrete or metal edges—were cutting into or abrading wires. In other cases, temperature changes resulted in the expansion and contraction of wires over time, moving the wires and resulting in their abrasion or exposure. In still other cases, conduits were overstuffed, containing too many wires to be safely used. And wire insulation failures resulted in the exposure of current-carrying electrical conductors to the elements, creating a substantial safety and fire hazard. By degrading the insulation of the solar panels' wiring, these factors increased the risk that an electric current would deviate from its intended path and cause a fire that would spread to surrounding panels. Many of these issues could have been—but were not—addressed through industry standard maintenance procedures, including resealing or reinsulating exposed wires.

Image of Wires Exposed to Sharp Edges

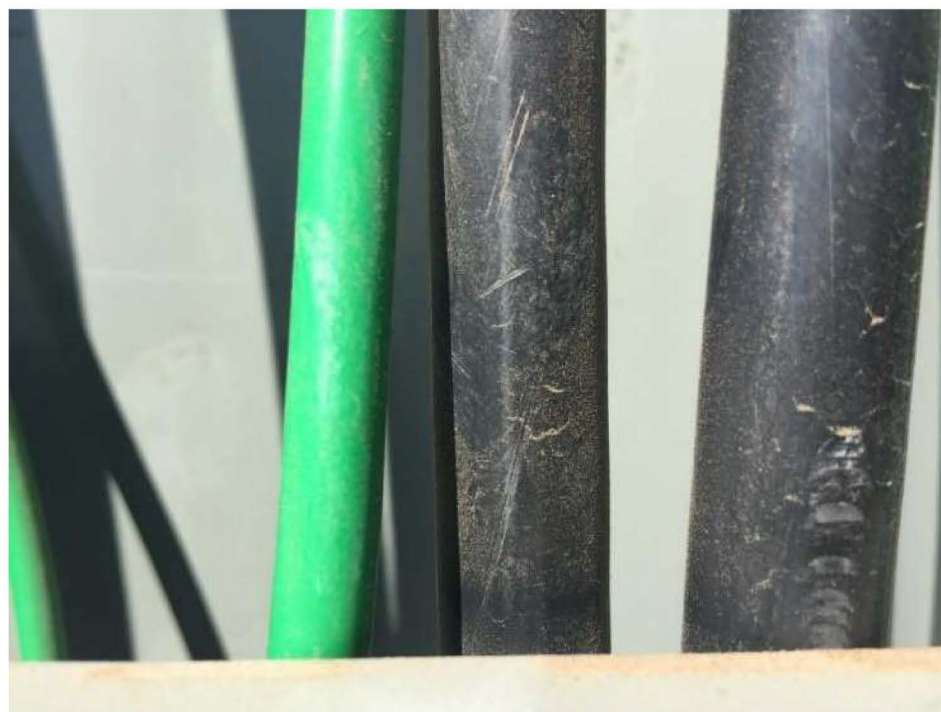
Images of Abraded Wires

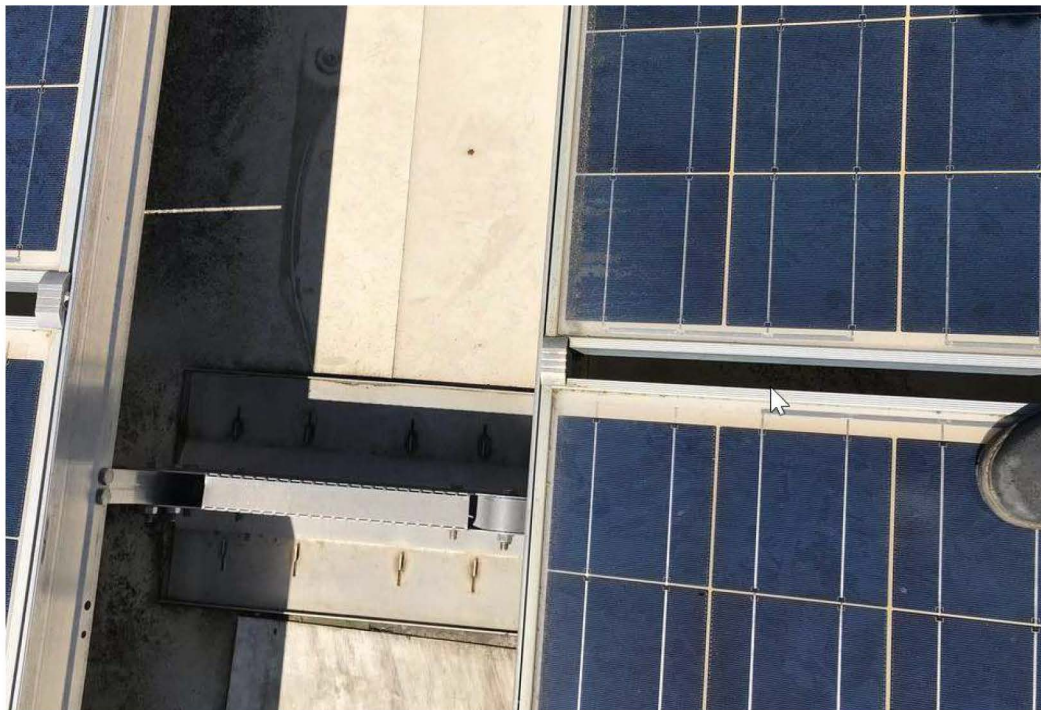
96. Tesla inspection personnel frequently missed or improperly identified obvious and visible risks with the solar panel systems and were often negligent in performing inspections. Most glaringly, Tesla inspection personnel violated elementary safety standards by negligently stepping on modules (potentially contributing to micro-cracks), using the wrong equipment for basic tasks, and—in one instance—leaving a combiner box enclosure open and exposed to the elements after an inspection. Tesla also relied on drone fly-overs and other shortcuts when inspecting sites, rather than sending qualified and properly trained solar inspectors to physically inspect solar panel systems with appropriate equipment—the established industry method for conducting thorough inspections.

Image of Tesla Inspector Stepping on Solar Modules
(Inspector's Foot Visible in Bottom Right of Image)
